Test Report

Name of Sample:	CAMERA
Brand Name:	TYCO
Model No.:	ISL-T04M013-N, ISE-T04M013S-N, ISL-T04V013-N, ISE-T04V014S-N, ISE-T04V013S-N, ISE-T04M014S-N
Client:	Tyco Safety Products (Shanghai) Co., Ltd.
Manufacturer:	Tyco Safety Products (Shanghai) Co., Ltd.
Test Sort:	Commission Test
Test Item:	IK10

Shenzhen EBO Testing Center

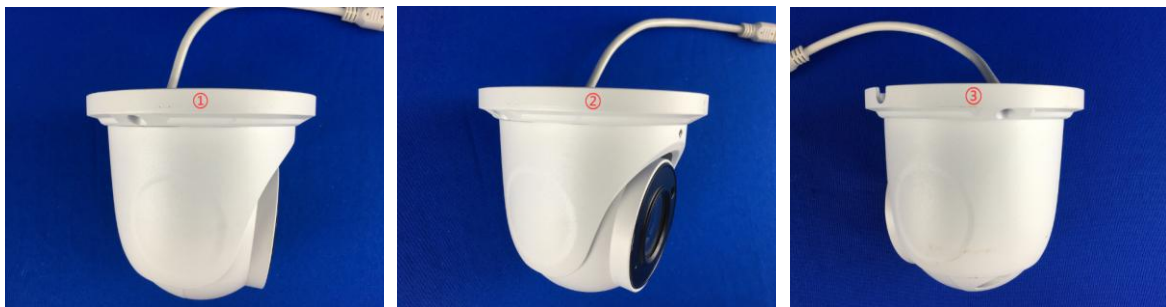
- Place the sample on the ground, drop the pendulum bob which weight is 5kg to impact the sample from a height of 400mm, the impact energy is 20J
- Impact 3 points on the surface of sample each for once

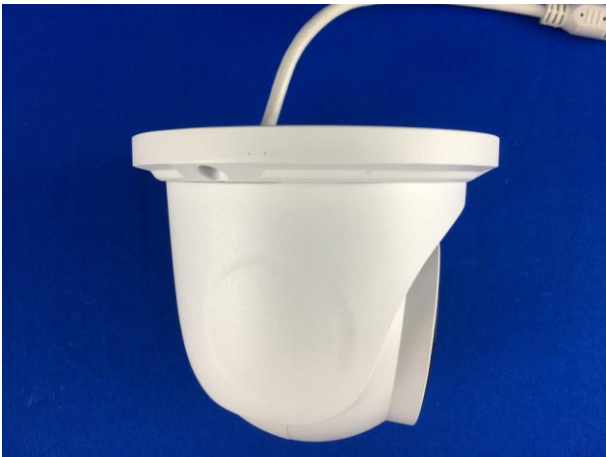
Visual check (Impact point 1)

Check Item Sample No.:	Visual check
1#	After testing, the surface of the sample was not damaged at 3 impact points
