Test Report

Name of Sample:	CAMERA
Brand Name:	TYCO
Model No.:	ISL-B04V013-N, ISE-B04F363S-N, ISE-B04F063S-N, ISE-B04V013S-N, ISE-B04M013S-N, ISE-B05F283S-N, ISE-B05F363S-N, ISE-B05F063S-N, ISE-B04F364-N, ISE-B04F284-N, ISE-B04V014S-N, ISE-B04M014S-N, ISE-B05F364-N, ISE-B05F064-N, ISL-B04M013-N
Client:	Tyco Safety Products (Shanghai) Co., Ltd.
Manufacturer:	Tyco Safety Products (Shanghai) Co., Ltd.
Test Sort:	Commission Test
Test Item:	IK10

Shenzhen EBO Testing Center

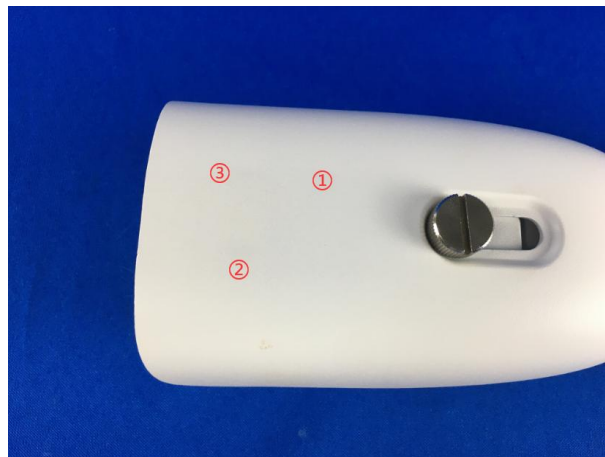
- (1) Place the sample on the ground, drop the pendulum bob which weight is 5kg to impact the sample from a height of 400mm, the impact energy is 20J
- (2) Impact 3 points on the surface of sample each for once

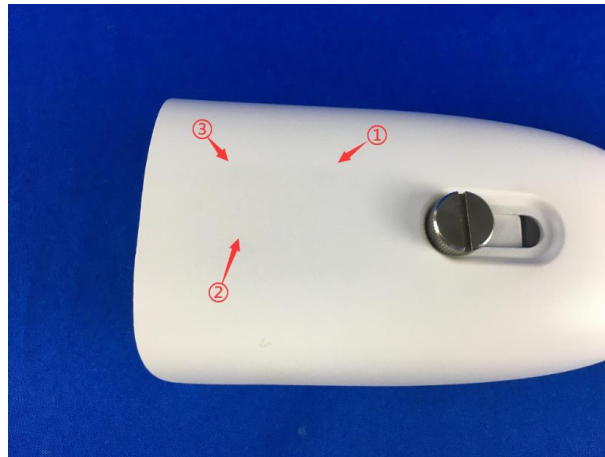
Check Item Sample No.:	Visual check
1#	After the test, all of the 3 impact points had been no broken with appearance.

Visual check (Impact point 1, 2, 3)
