# Test Report

<b>Name of Sample:</b>	CAMERA
<b>Brand Name:</b>	TYCO
<b>Model No.:</b>	ISE-V05F363S-N, ISE-V04F283S-N, ISE-V04F284-N, ISE-V04F363S-N, ISE-V04F364-N, ISE-V05F283S-N, ISE-V05F284-N, ISE-V05F364-N
<b>Client:</b>	Tyco Safety Products (Shanghai) Co., Ltd.
<b>Manufacturer:</b>	Tyco Safety Products (Shanghai) Co., Ltd.
<b>Test Sort:</b>	Commission Test
<b>Test Item:</b>	IK10

## Shenzhen EBO Testing Center

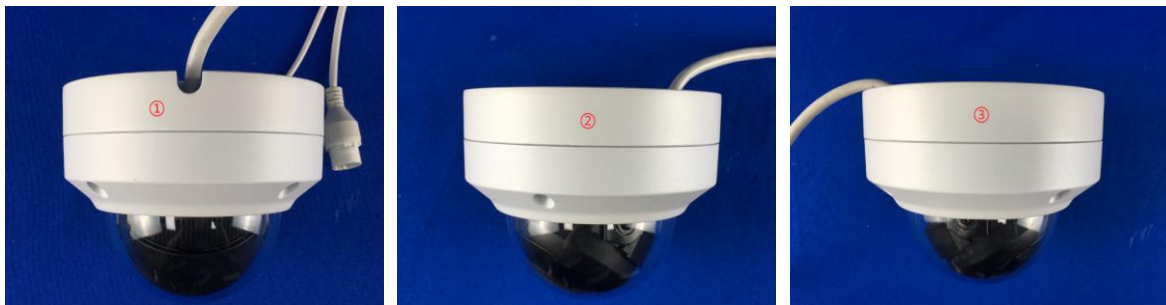
- (1) Place the sample on the ground, drop the pendulum bob which weight is 5kg to impact the sample from a height of 400mm, the impact energy is 20J
- (2) Impact 3 points on the surface of sample each for once

- (3) Examine the appearance of specimen by visual check after this test.

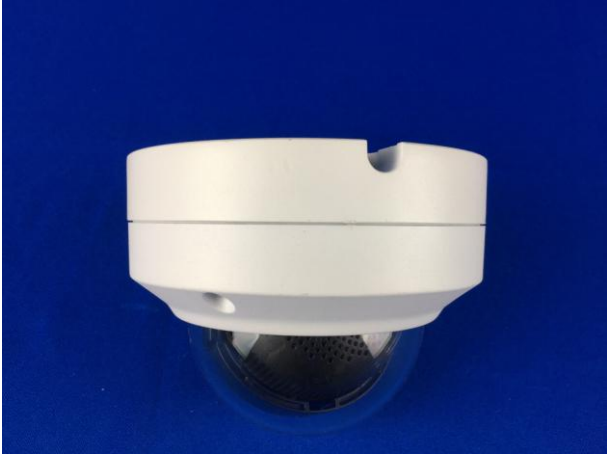
Visual check (Impact point 1)

Check Item Sample No.:	Visual check
1#	After the test, all of the 3 impact points had been no broken with appearance.
